Asbestos Inspection and Lead-Containing Paint Screening Report

St. Landry Bank – Eunice Branch

101 North 2nd Street

January 14, 2025 | Terracon Project Number: EH247233

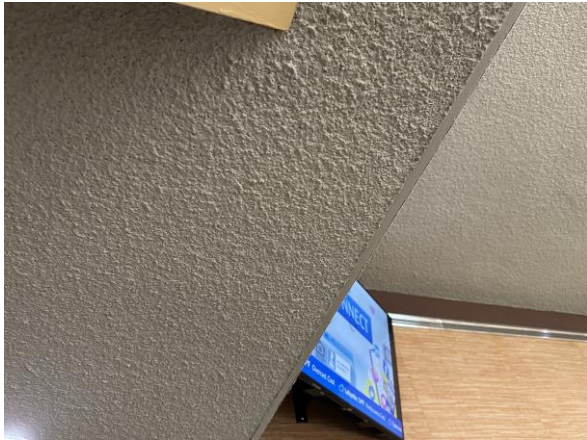
Photo 1 HA-1: White popcorn ceiling

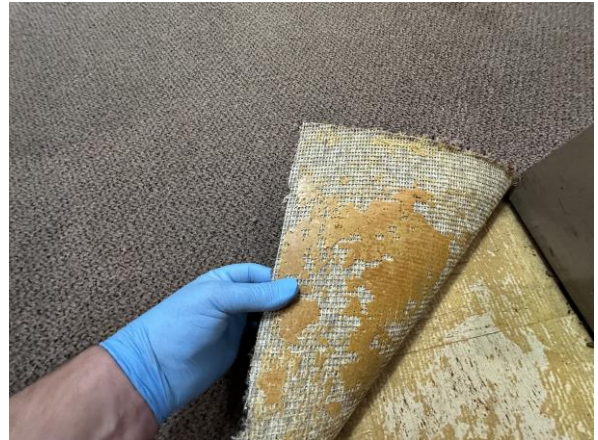
Photo 2 HA-2: Yellow carpet mastic

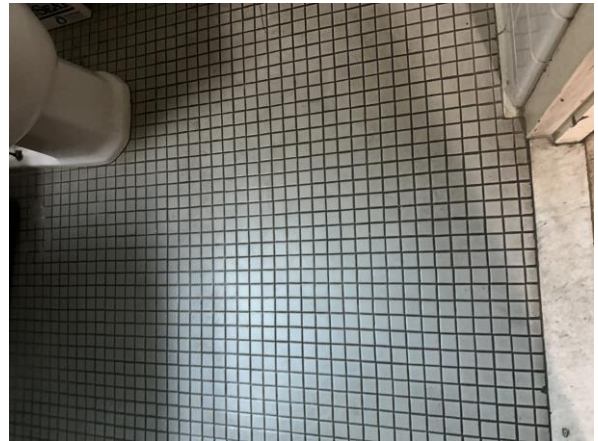
Photo 4 HA-4: 1"x1" Green ceramic floor tile with grout

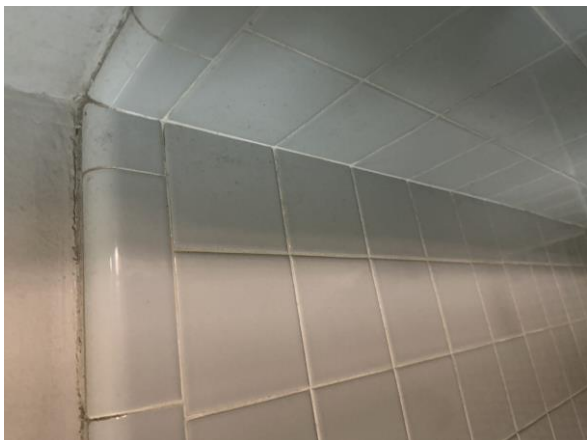
Photo 5 HA-5: 3.5"x3.5" Green ceramic wall tile with grout

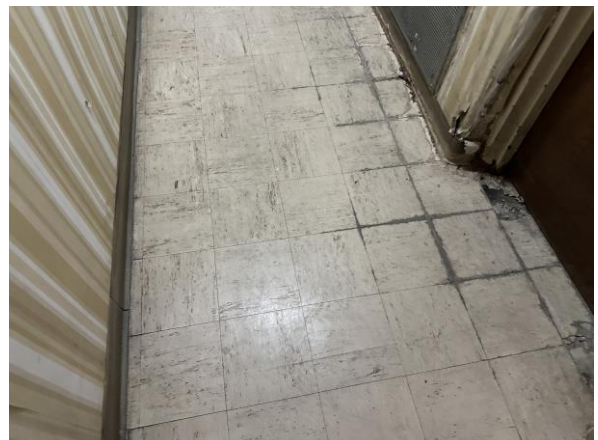
Photo 6 HA-7: 4" Brown cove base with mastic

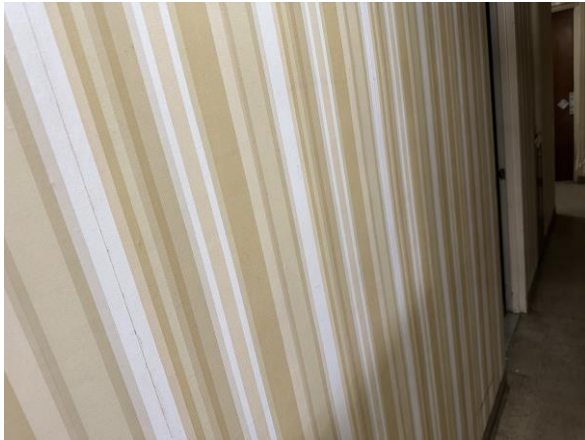
Photo 7 HA-8: Beige and white striped wallpaper

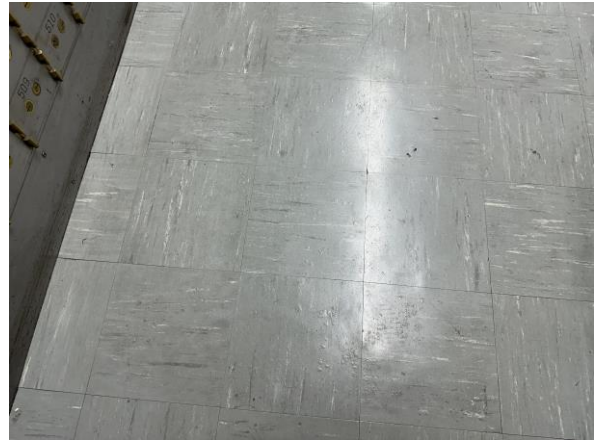
Photo 8 HA-9: 9"x9" Grey and white floor tile with black mastic

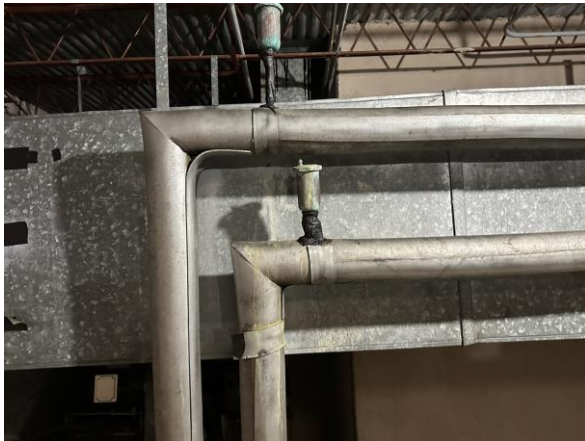
Photo 9 HA-10: Black asphalt patching at pipe connection joints

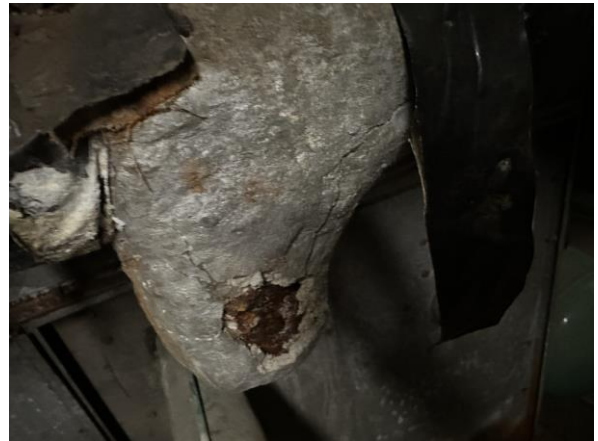
Photo 10 HA-11: Grey and white plaster patching at connection points

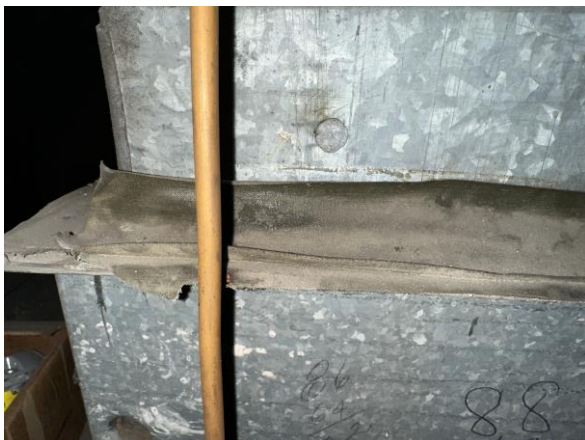
Photo 11 HA-12: Black HVAC seal

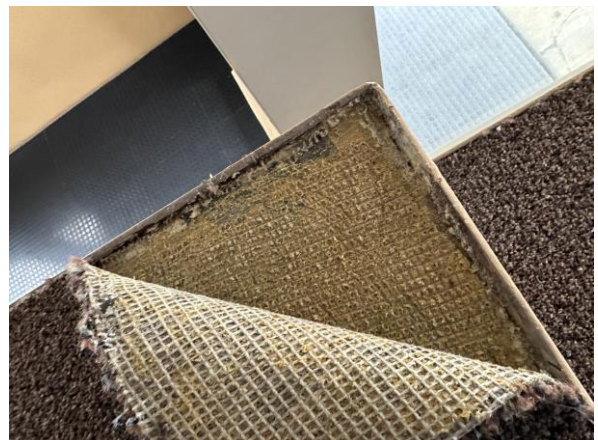
Photo 12 HA-13: Yellow carpet mastic (stairwells)

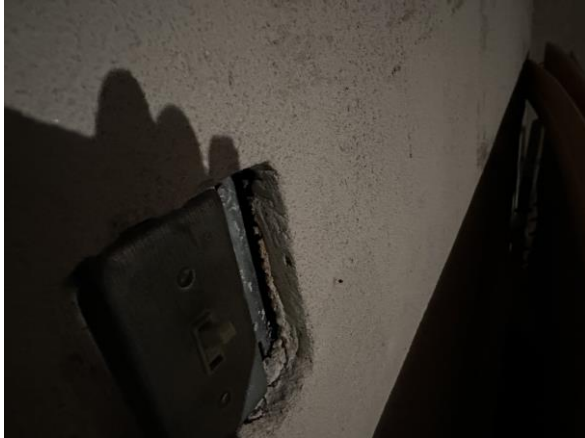
Photo 13 HA-17: Beige cement wall coating

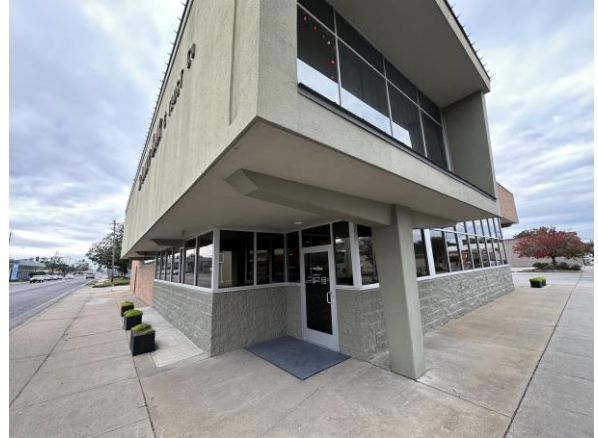
Photo 14 HA-19: Exterior stucco

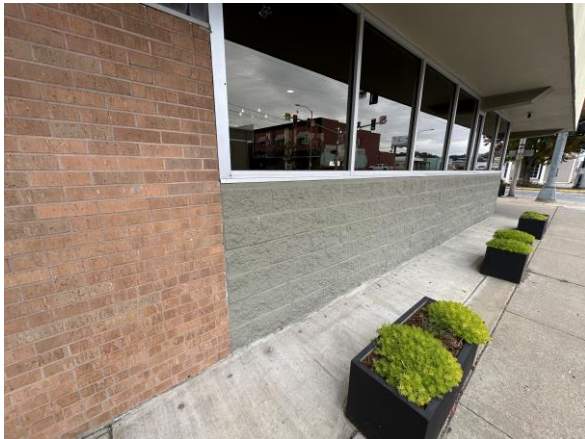
Photo 15 HA-20: CMU blacks and mortar

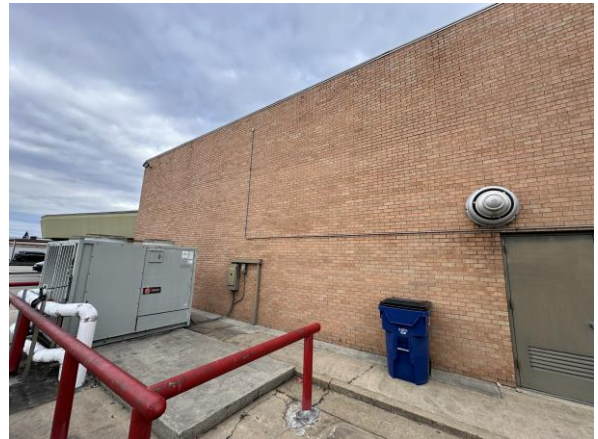
Photo 16 HA-21: Red bricks and grey mortar

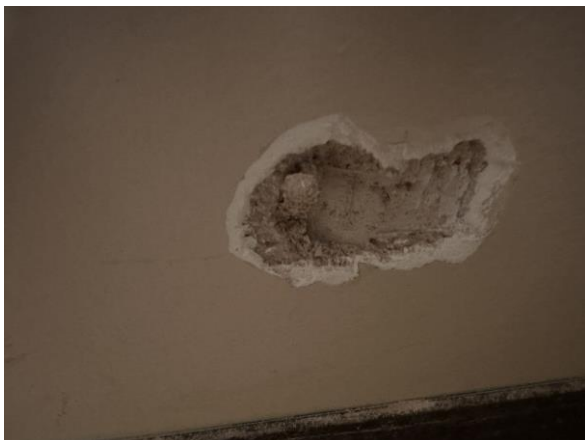
Photo 17 HA-22: Hard plaster material skim coat over cement walls
