NOTE: DETAILED SECTIONS REPLICATED FROM ORIGINAL CONSTRUCTION DOCUMENTS

Office of the State
Public Defender
District 8 Office
Building

111 West Main Street
Winnfield, LA 71483

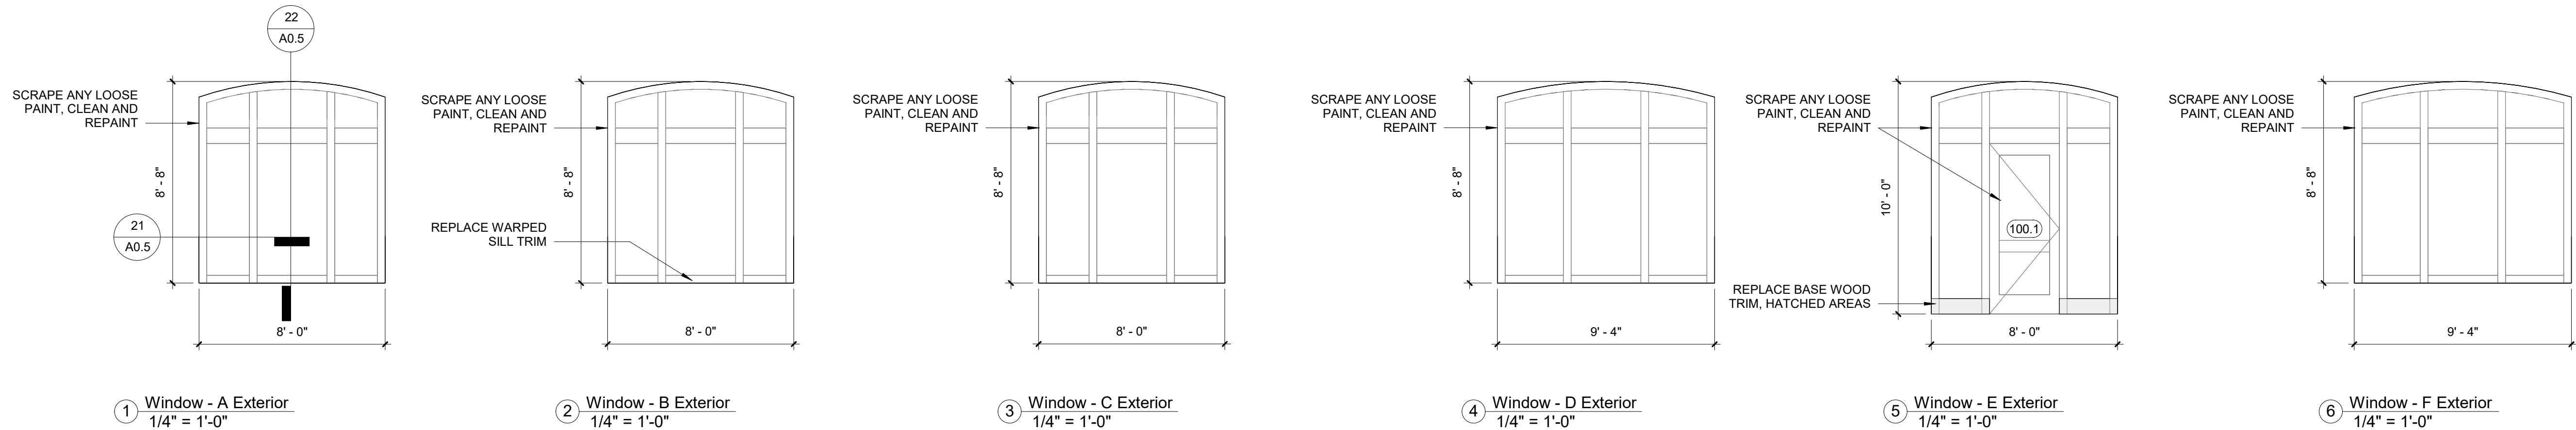
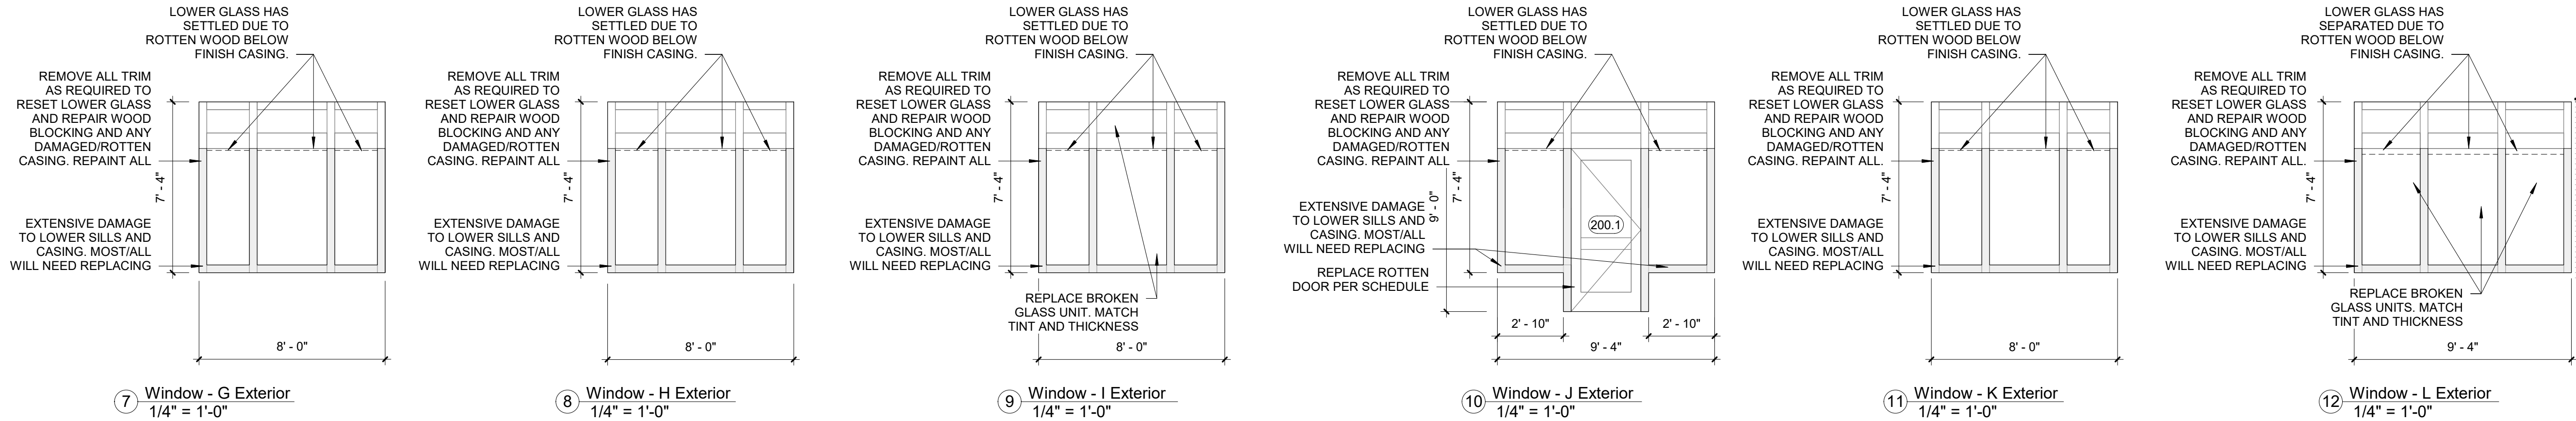
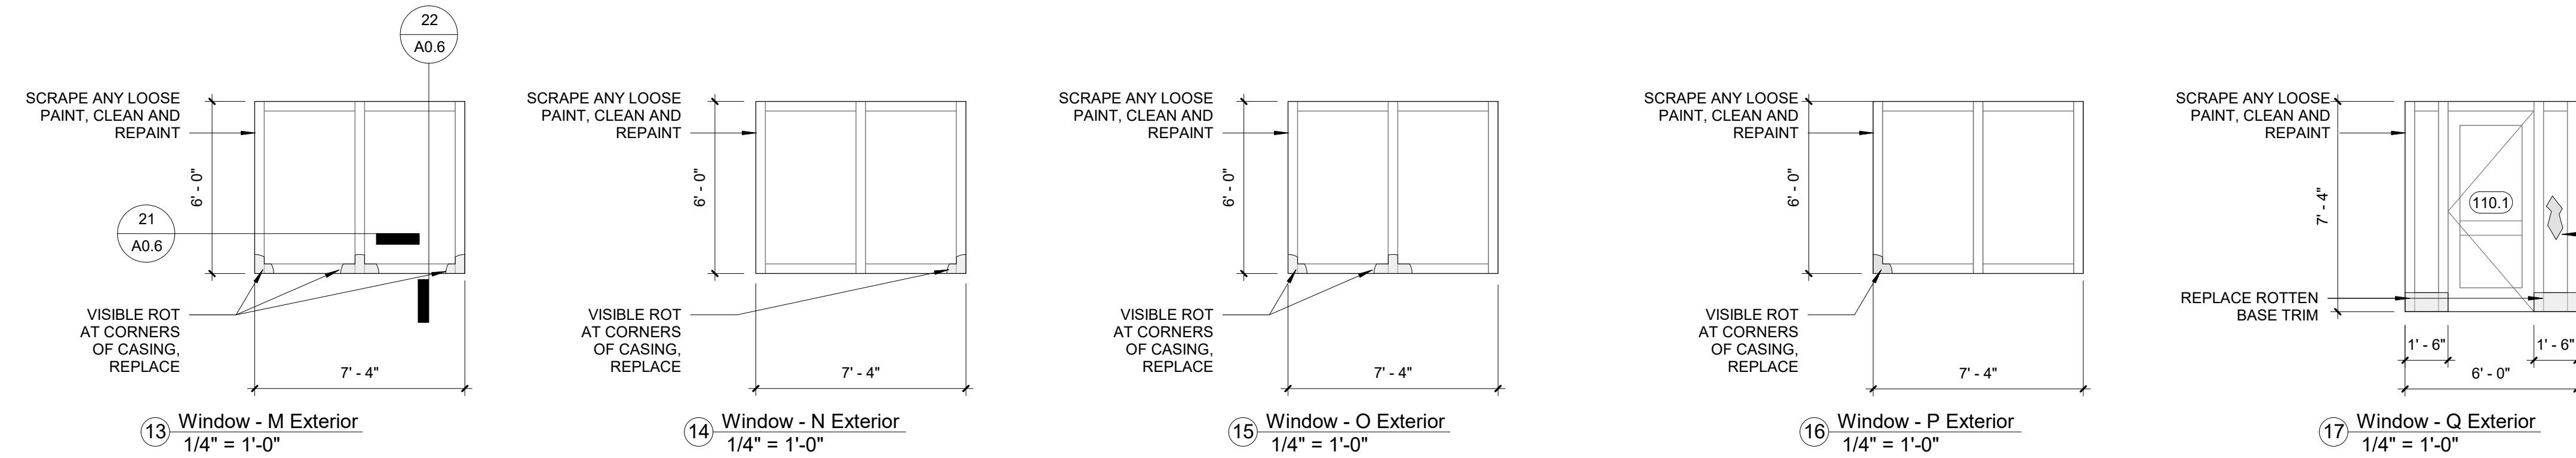
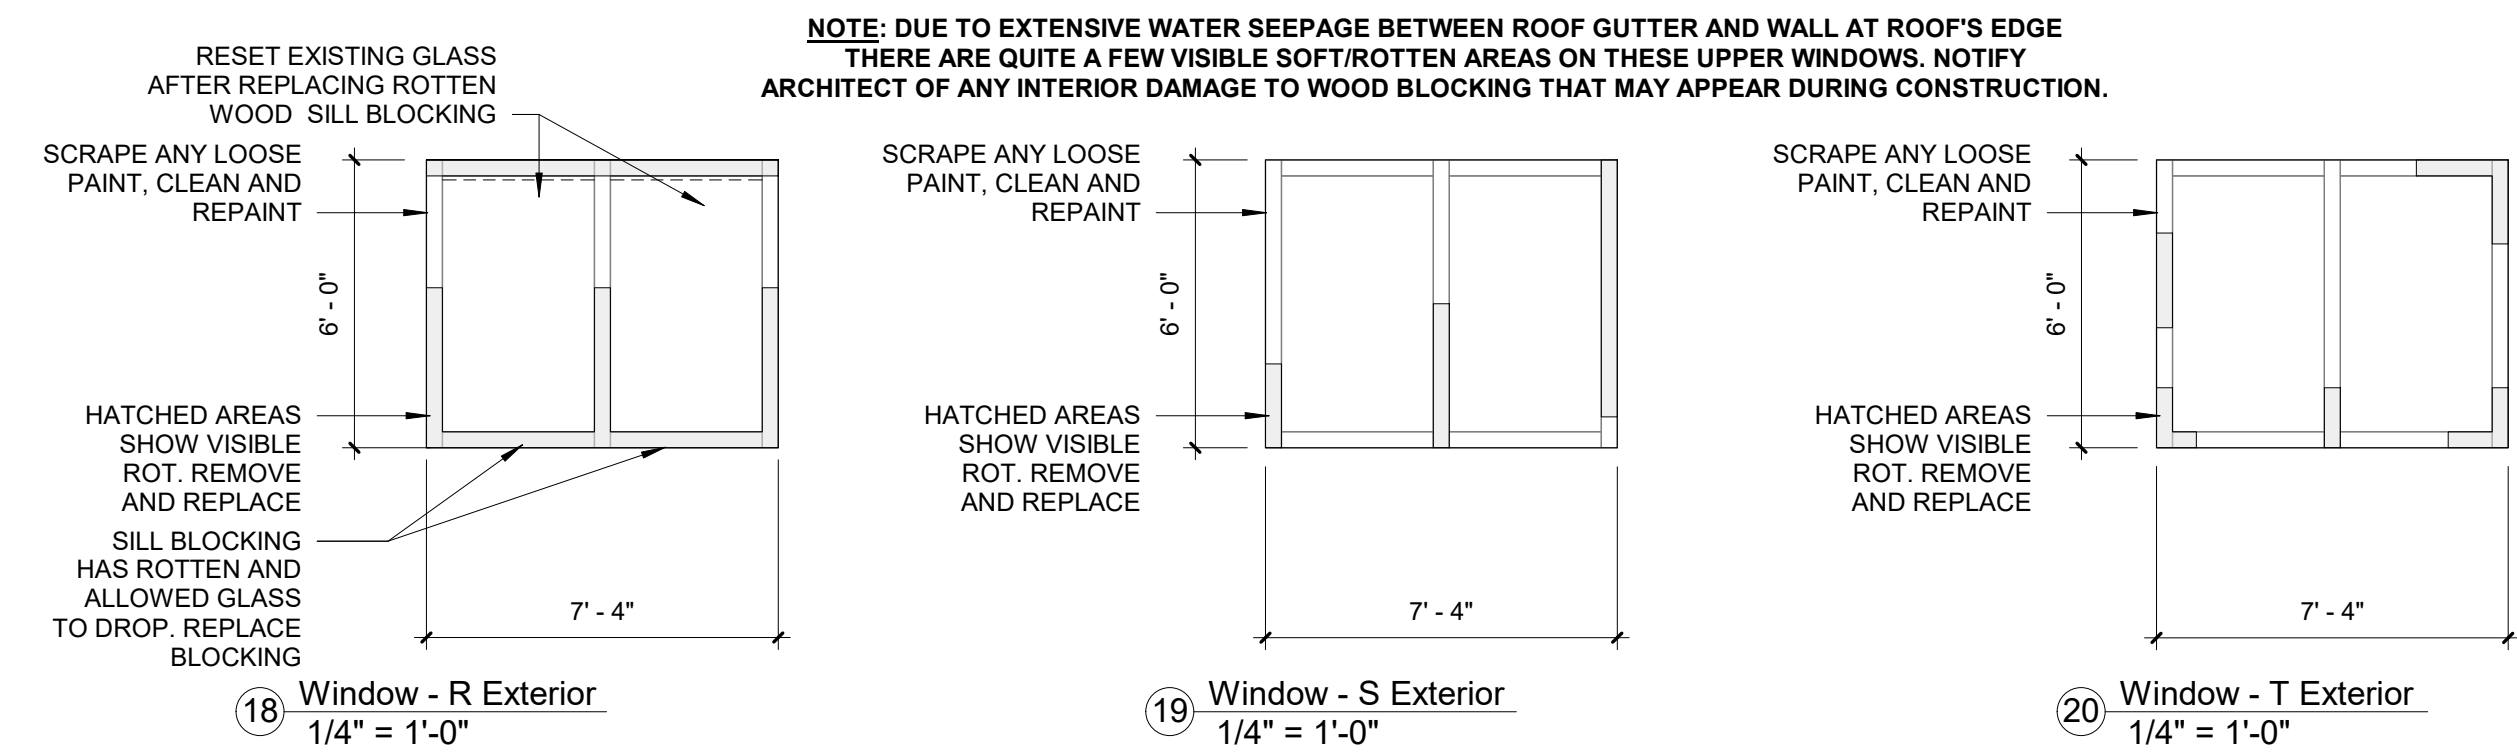
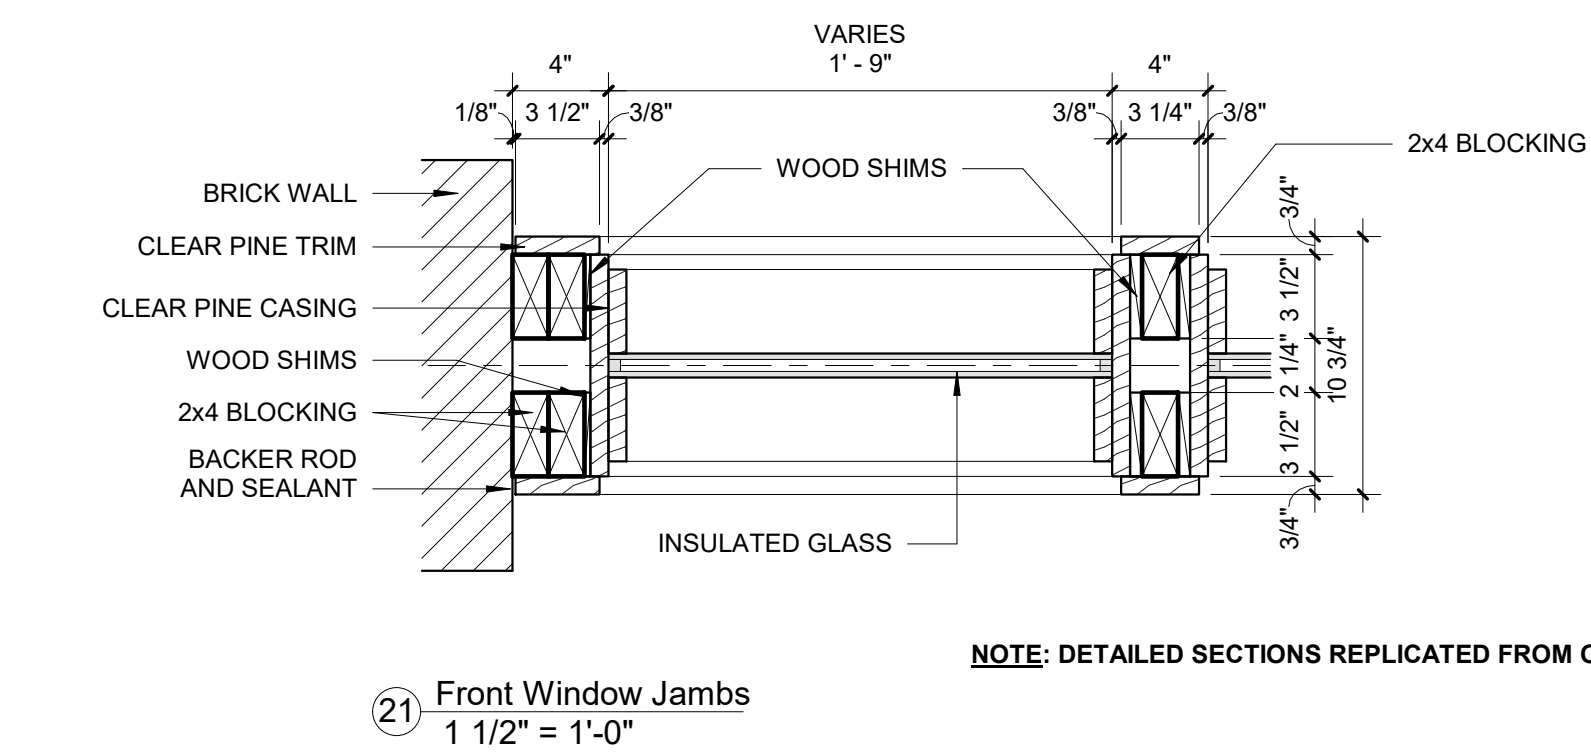
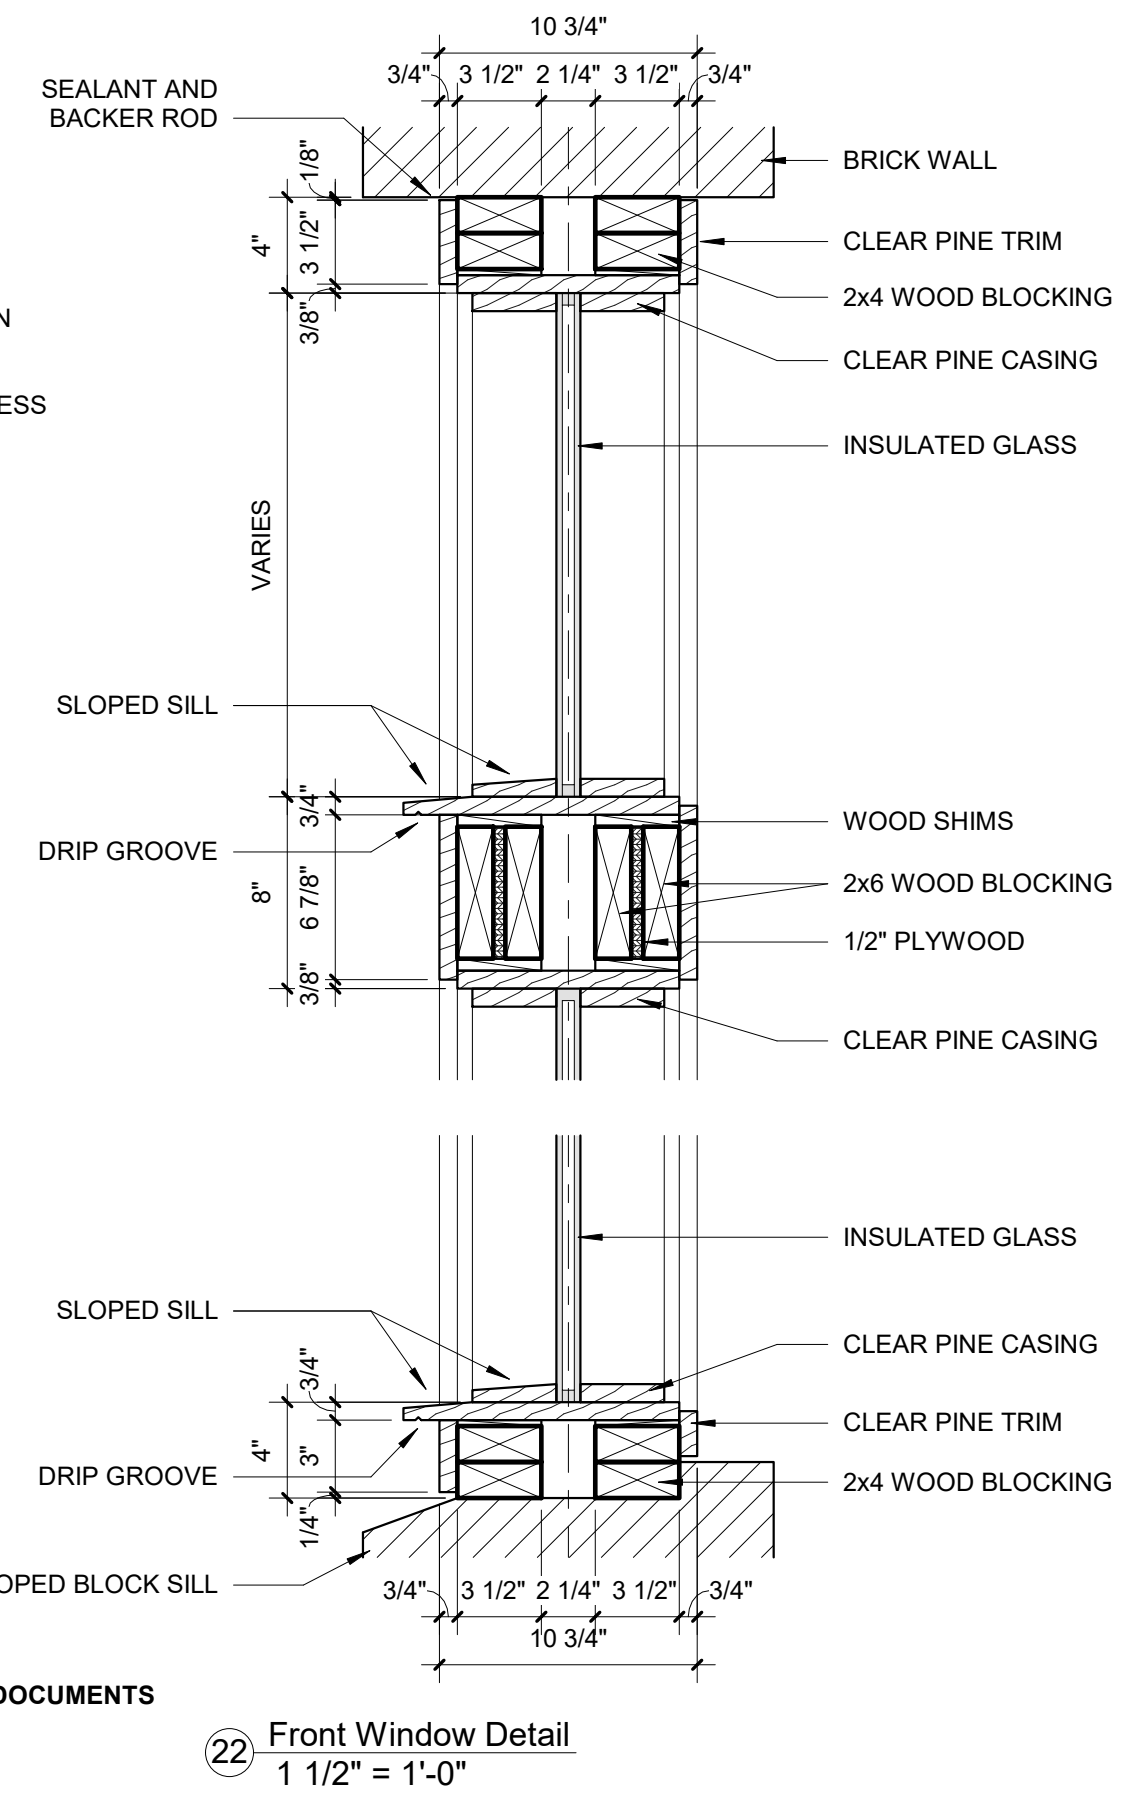
NOTE: DUE TO EXTENSIVE WATER SEEPAGE BETWEEN ROOF GUTTER AND WALL AT ROOF'S EDGE THERE ARE QUITE A FEW VISIBLE SOFT/ROTTEN AREAS ON THESE UPPER WINDOWS. NOTIFY ARCHITECT OF ANY INTERIOR DAMAGE TO WOOD BLOCKING THAT MAY APPEAR DURING CONSTRUCTION.
